## Case Study 2

Location: North England, Railway shunting yard

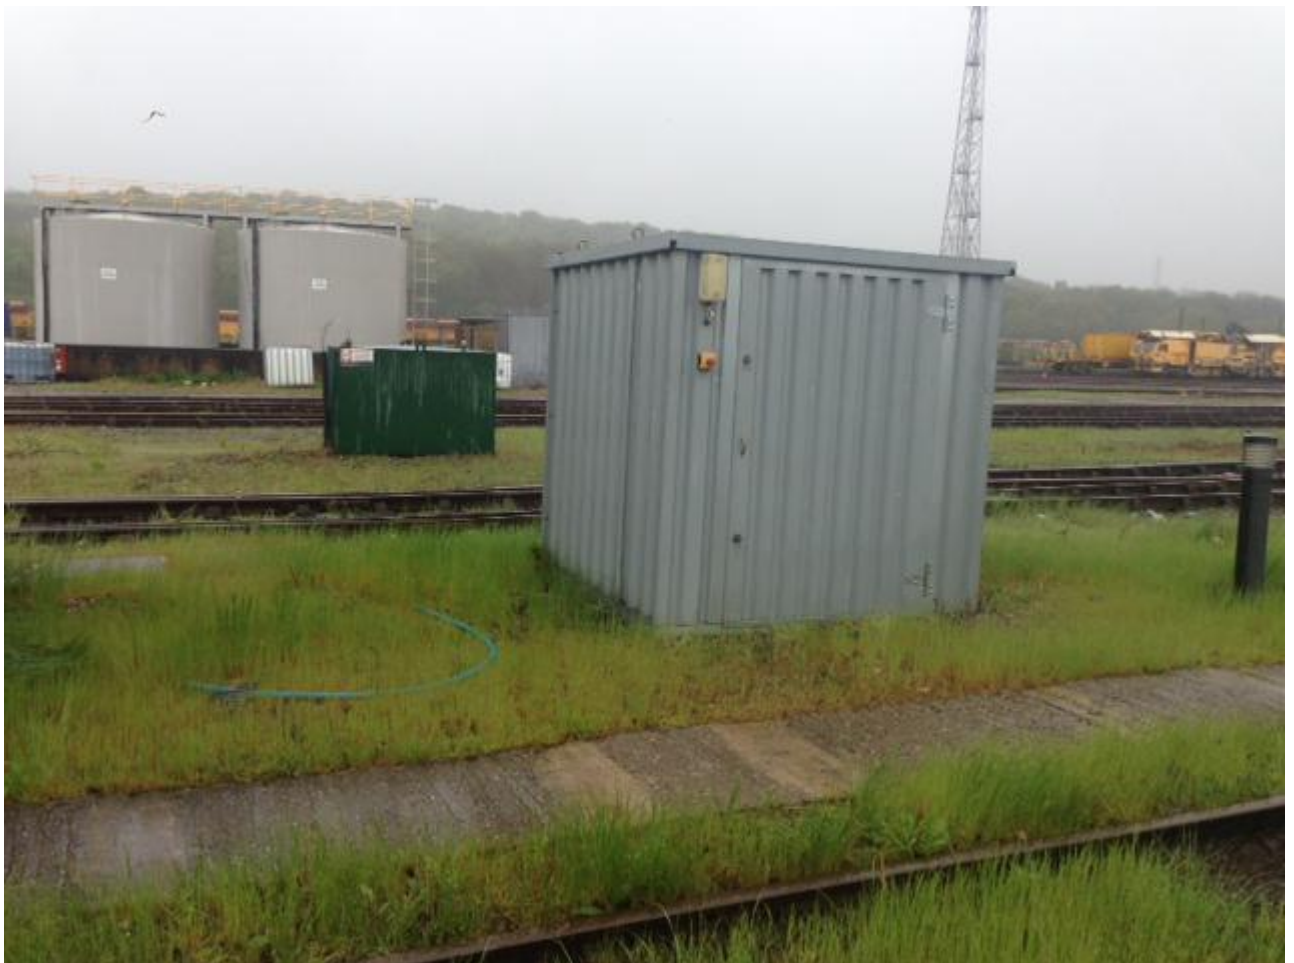
The hotspot near the track have been identified and over the last 10 years has had a 8 ADJ1000 pumps that are split into two zones.

Each Zone has: 1. x4 pumps

2. 1 container with compressor, multi-stage timer, Air dryer, Holding tank with level switch.

Results: Since the system has been installed and with bi monthly maintenance has recovered over 100,000 litres.
